YOUTH AND WOMEN OPPORTUNITIES UGANDA [YWOU]

BOREHOLE SITING REPORT

**REPORT FOR BOREHOLE SITING, DESIGN AND DRILLING, DRILLING
SUPERVISION, PUMP TESTING AND COMPLETION REPORT OF 01 DEEP
BOREHOLE IN AGIRIGIROI IN SERERE**

DECEMBER 2018-JULY 2019

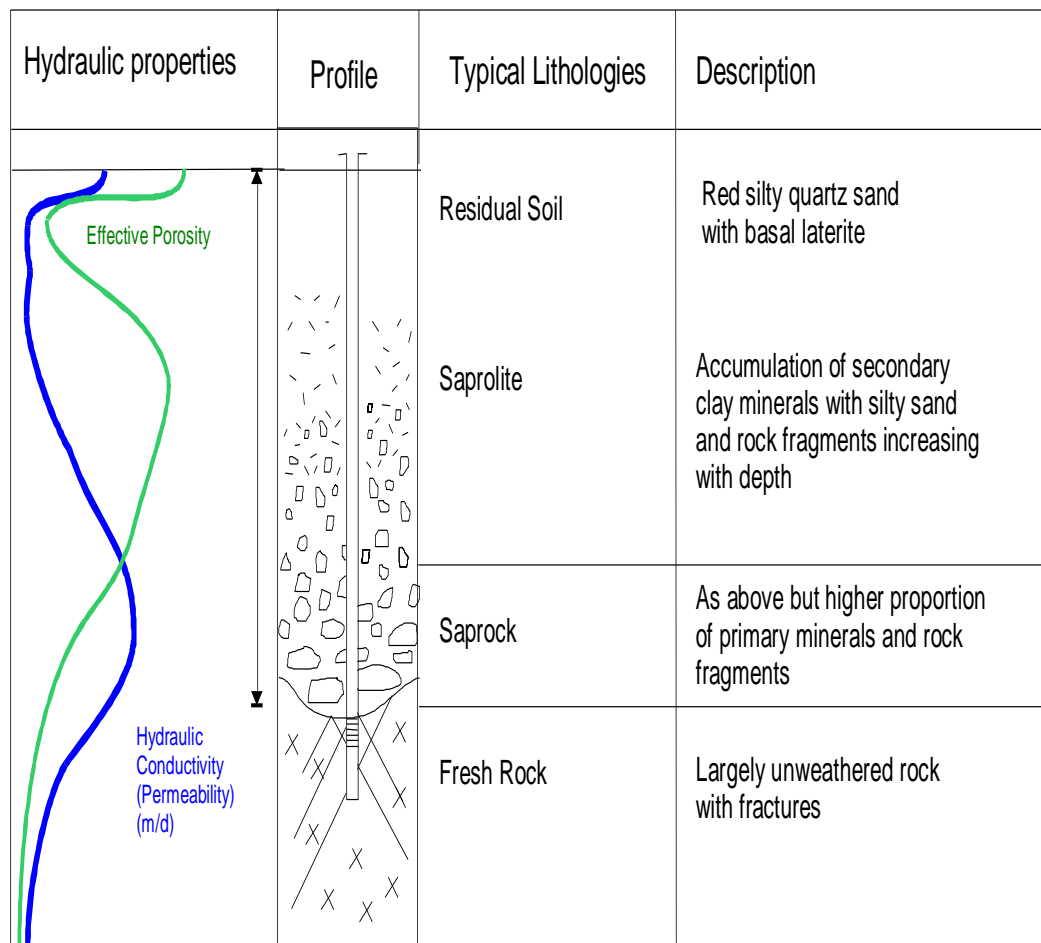
Figure: Schematic Profile of a Typical Basement Regolith Aquifer

The analysis of existing borehole data indicates an average first water strike depth of 24 m and a main water strike depth of 47.0m.

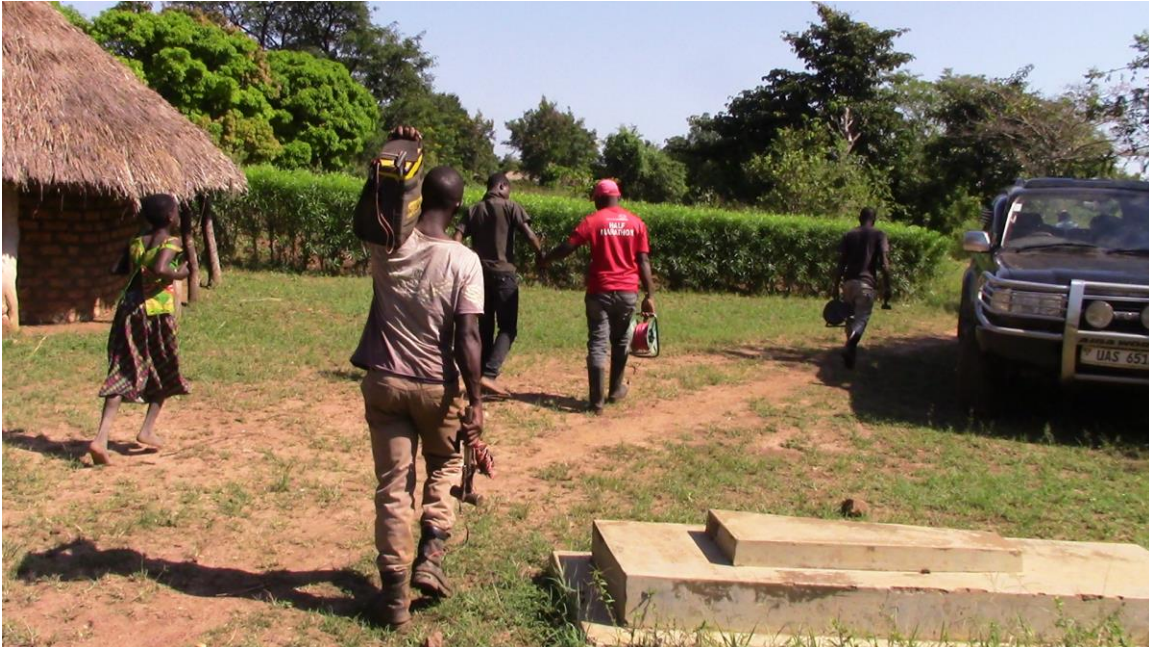
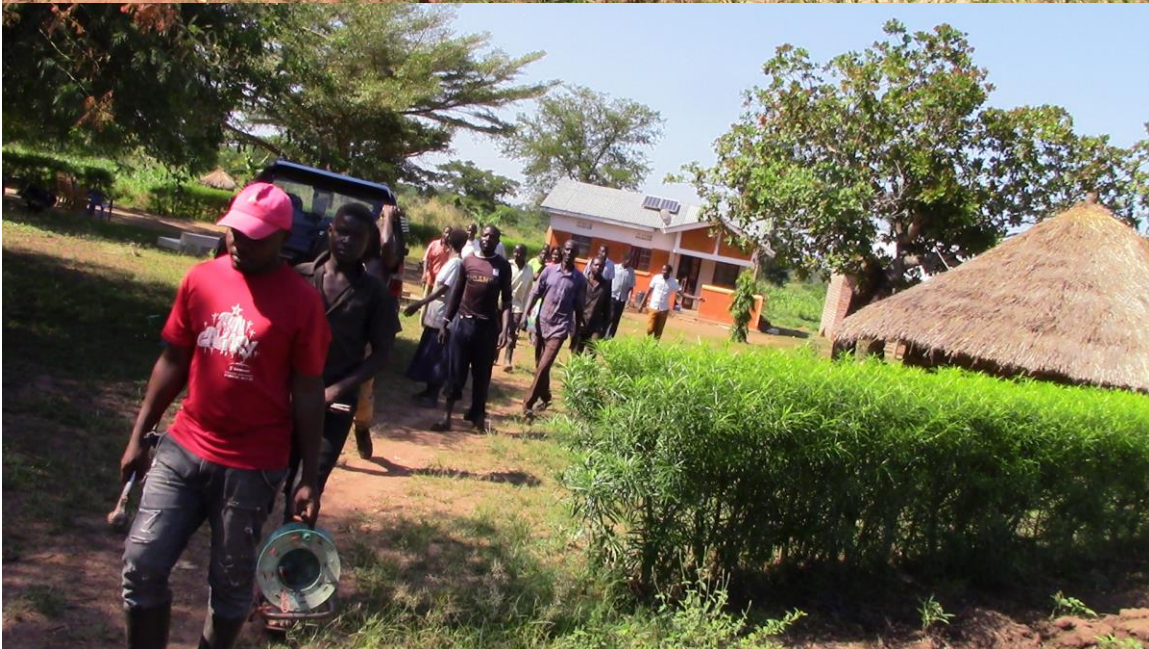
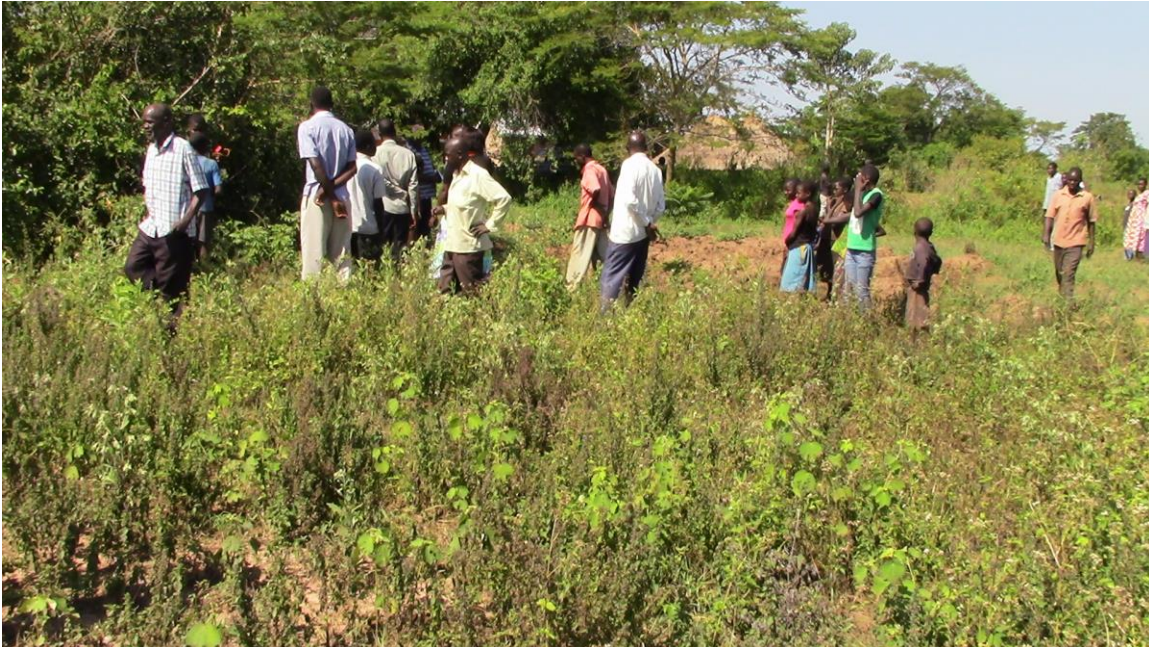
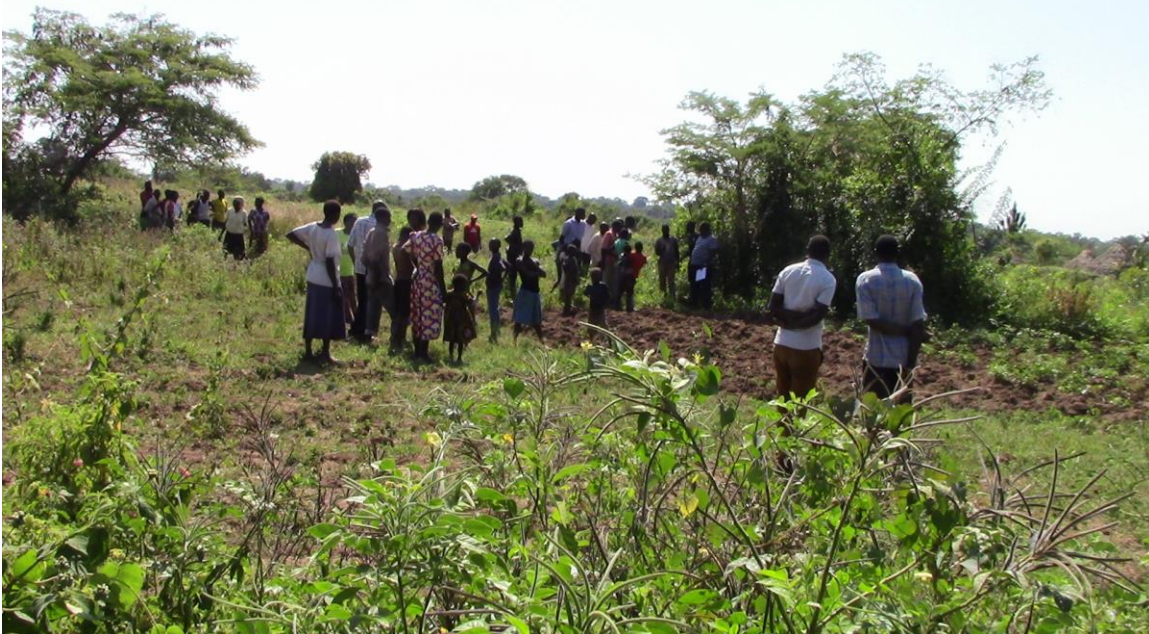
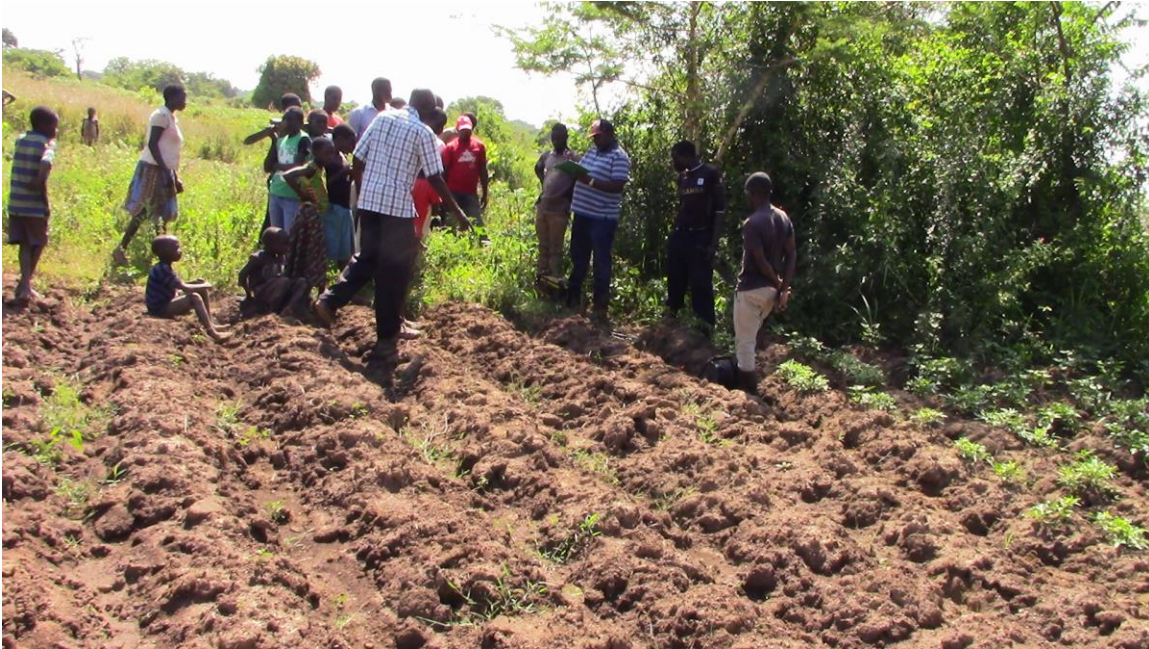
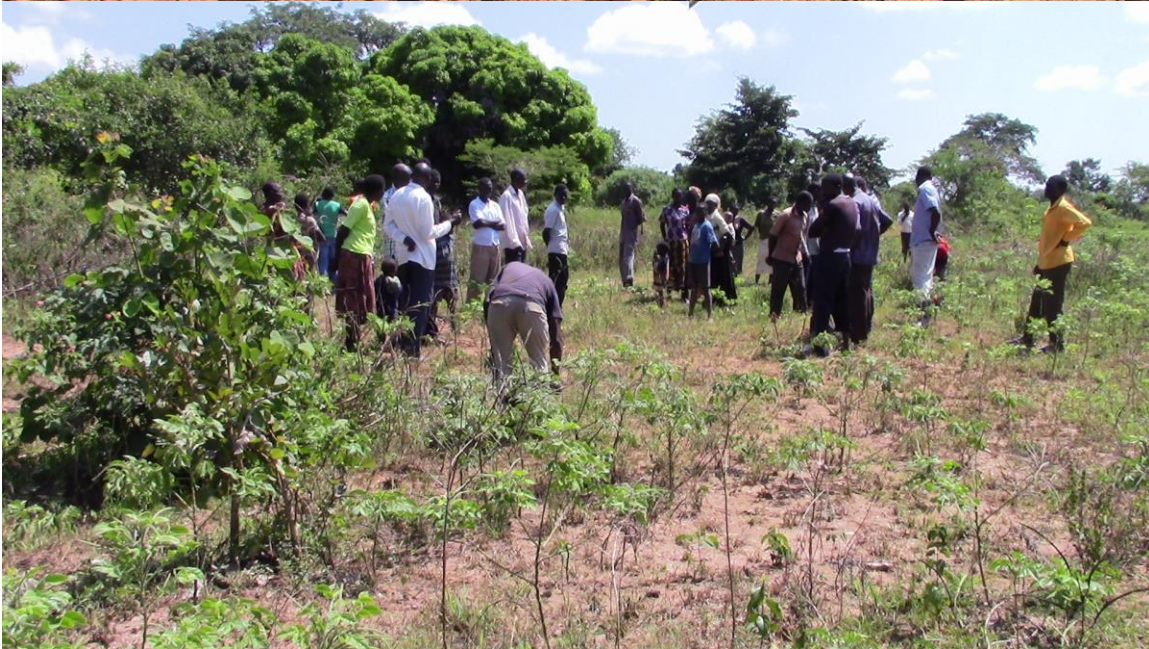
The resistivity profiles were run with AB (current electrode separation) of 58 and 83m and a station interval of 10m, MN (potential electrode separation) was fixed at 10m. The aim of a survey with resistivity profiles is to map anomalous resistivity values. These may be caused by presence of a fractured zone and or deeper weathered section that may be favourable for groundwater abstraction. Profiles were run across the lineament features previously identified from the aerial photograph interpretation. Precise location of the Resistivity Anomaly (PLRA) method was used to determine lineament direction and investigate further the best identified VES for sites on the profile.

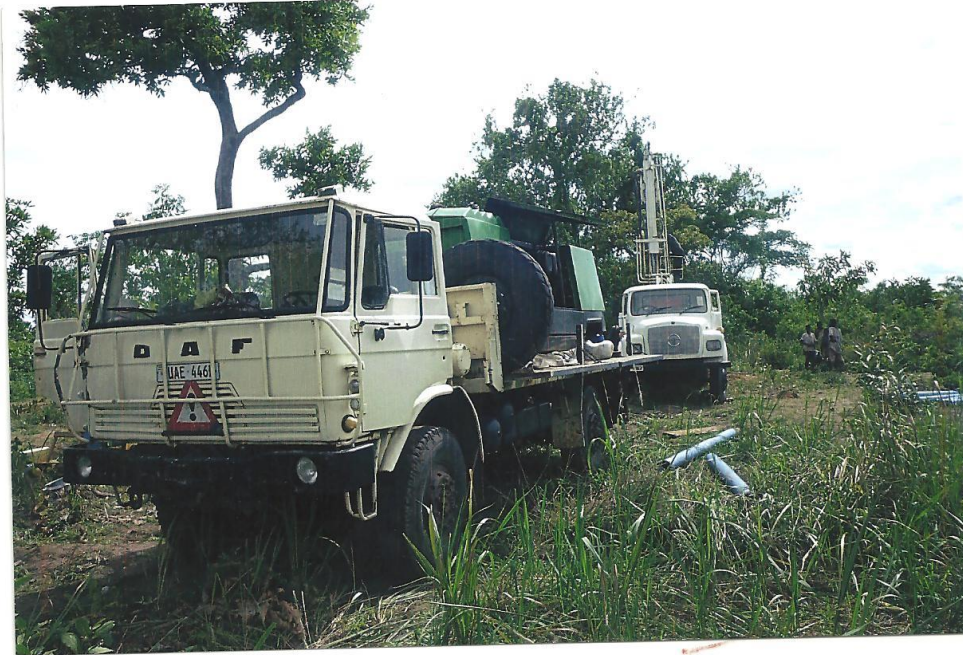
The Contractor Mobilises the equipment to the site

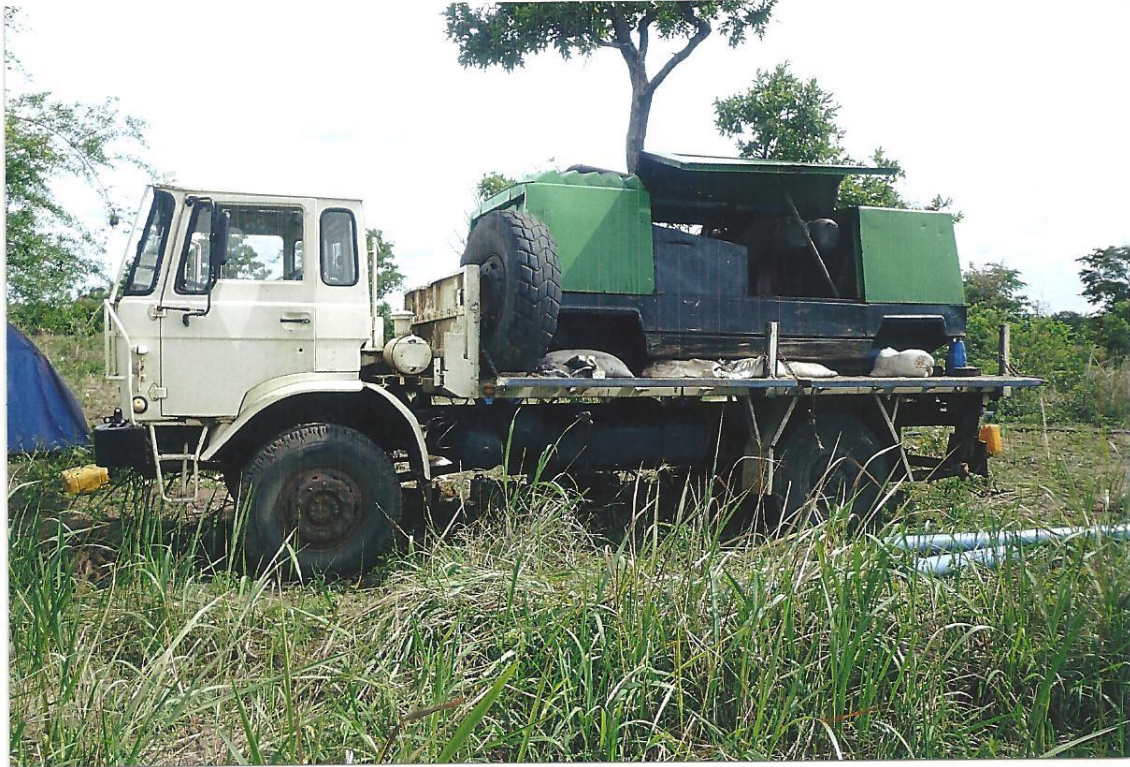
The Compressor takes position to start drilling

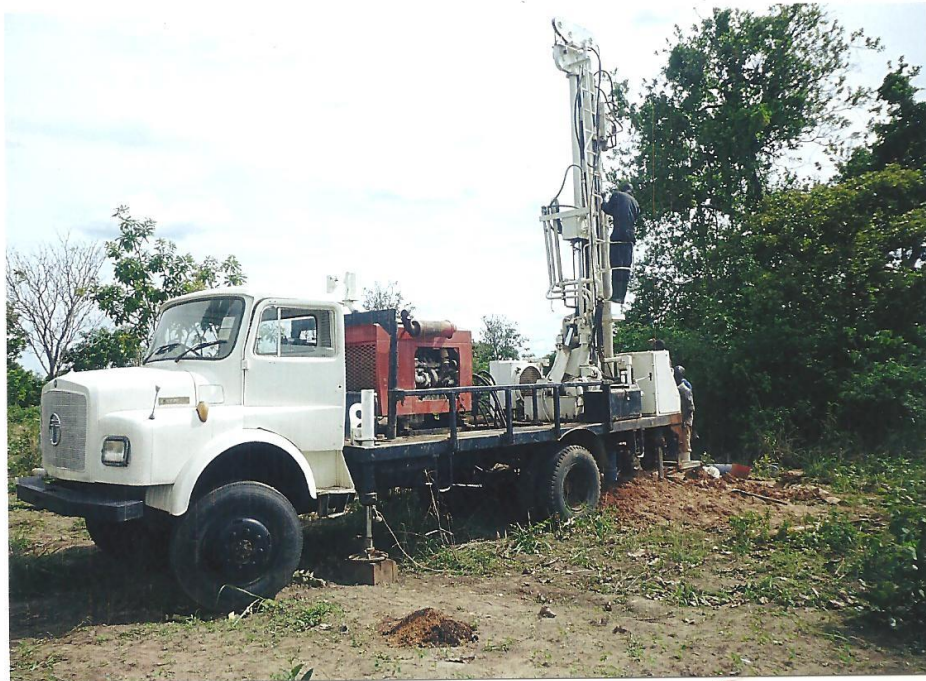
The rig starts the drilling process

The drilling of 01 deep borehole was carried out by ERIKA contractors and supervised by the district water Engineer. The contractor was assigned forms in advance and the contractor drilled exact location identified during the siting and designated by the supervisor. The driller then rigged up above the site and drilled borehole to the depth specified in the sitting report or whenever enough water was realised to the satisfaction of the supervisor. Competent formation was generally encountered and their rotary drilling method was employed in both regolith and bedrock. Yield estimates were made for all the measurable strikes. Lithological samples were collected at the intervals of 1 meter as per the contract.

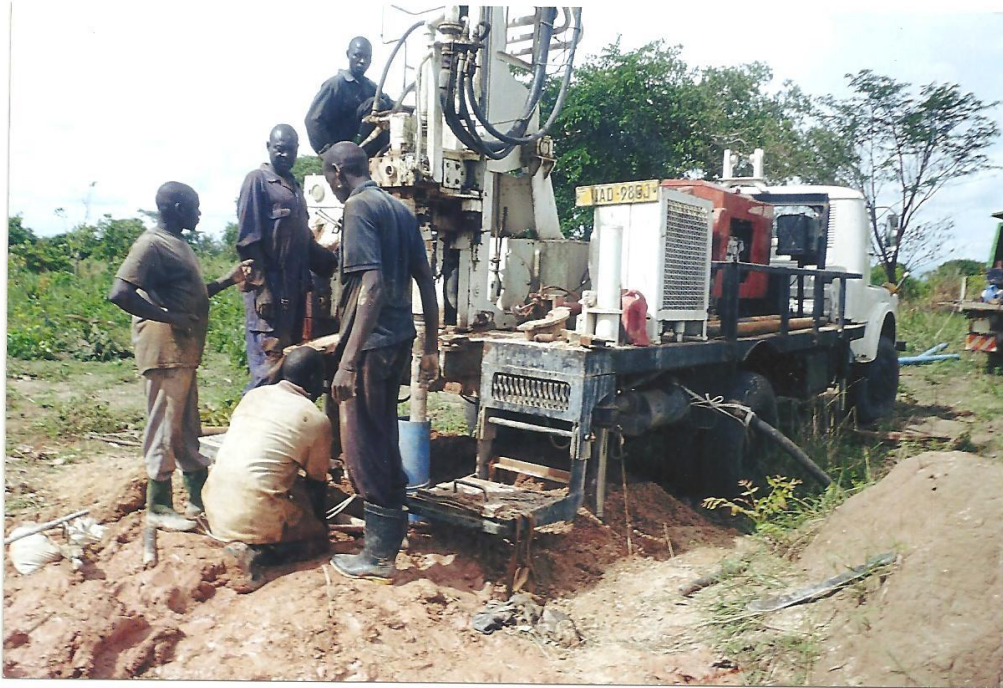
Siting report for 01 hand pump borehole
Youth and Women for Opportunities Uganda [YWOU] MCW 2018/220
Drilling in Progress

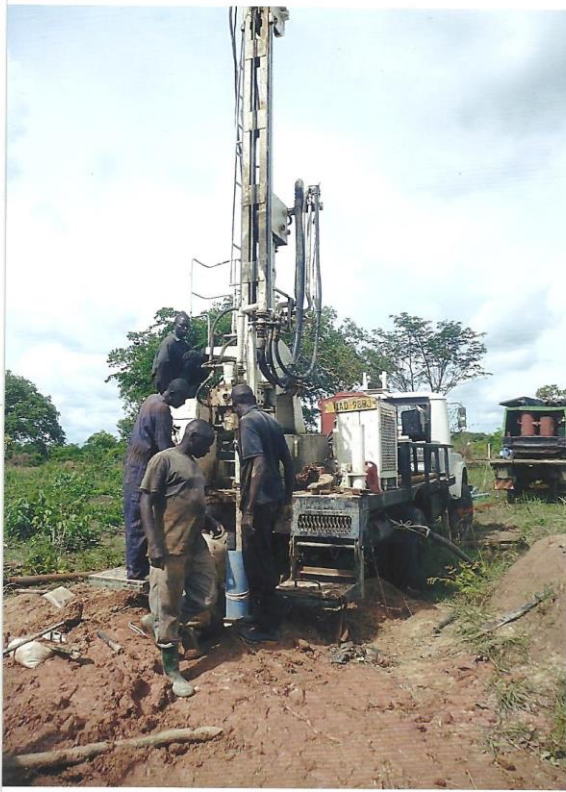
The Rig drills the well

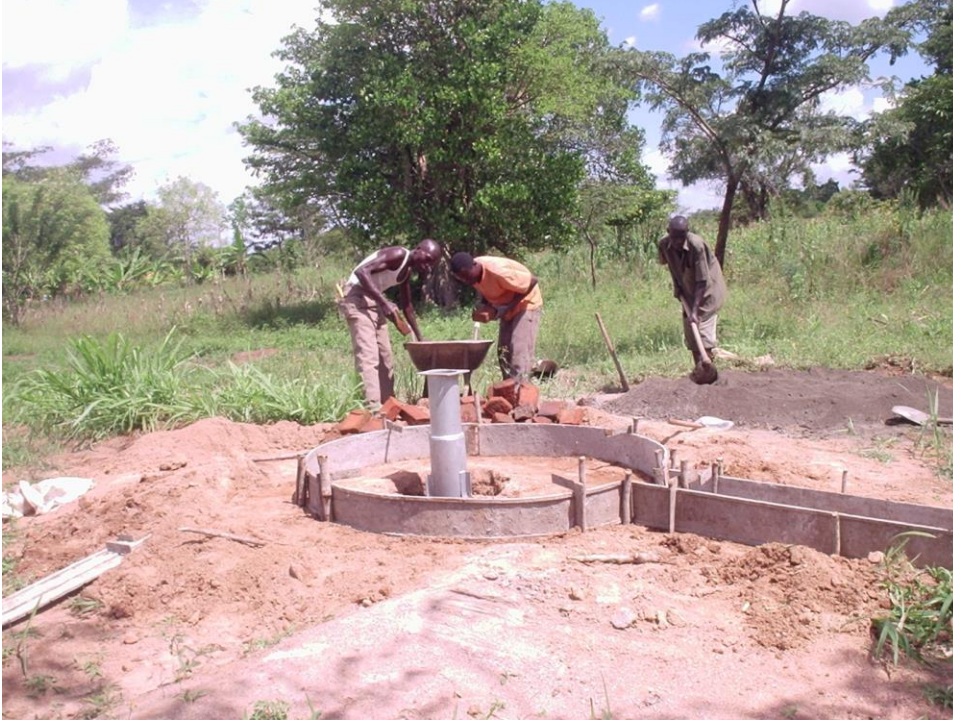
Siting report for 01 hand pump borehole
Youth and Women for Opportunities Uganda [YWOU] MCW 2018/220
Casting of the new Borehole

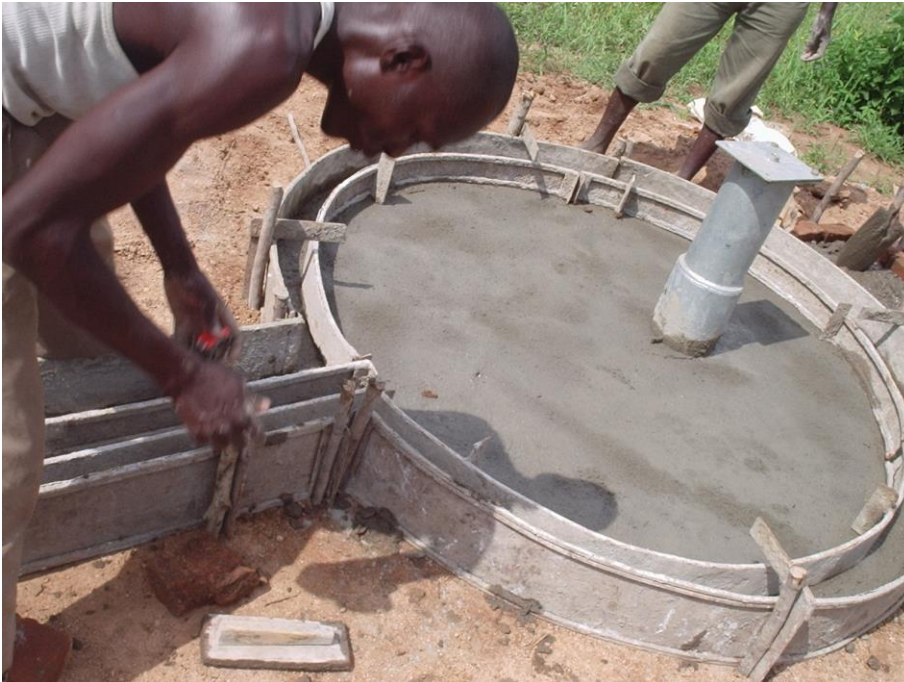
Casting of the Borehole in Progress

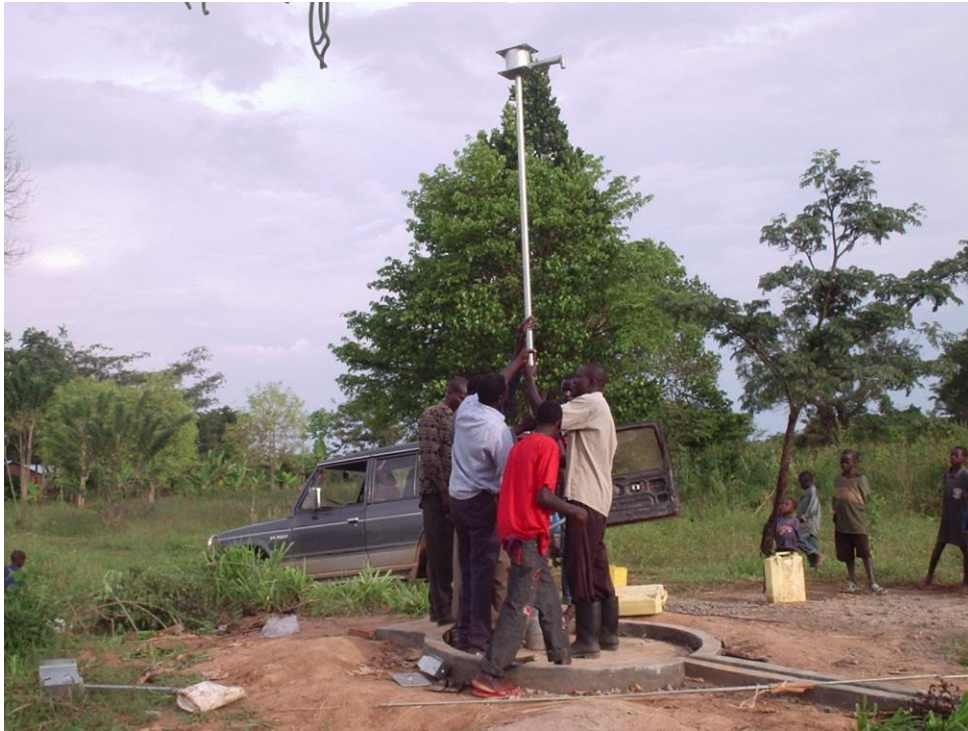
Fixing of the water hand pump

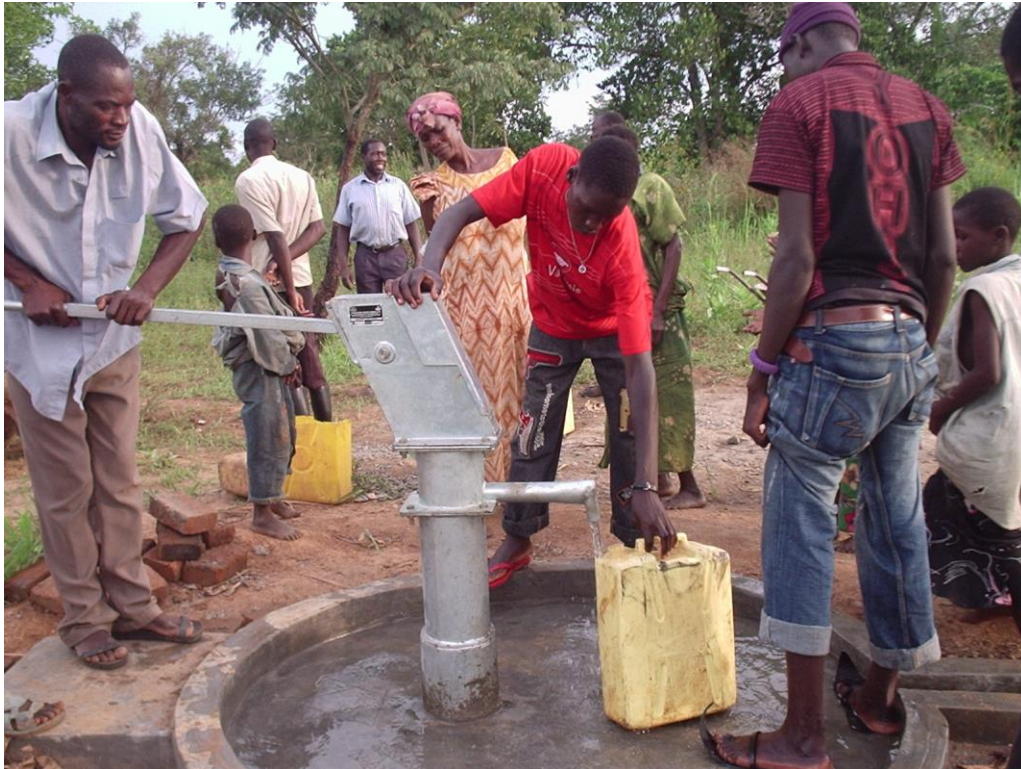
Test Hand Pumping of the new water source
